Therese McAllister Jonathan Barnett John Gross Ronald Hamburger Jon Magnusson

1Introduction

1.1 Purpose and Scope of Study

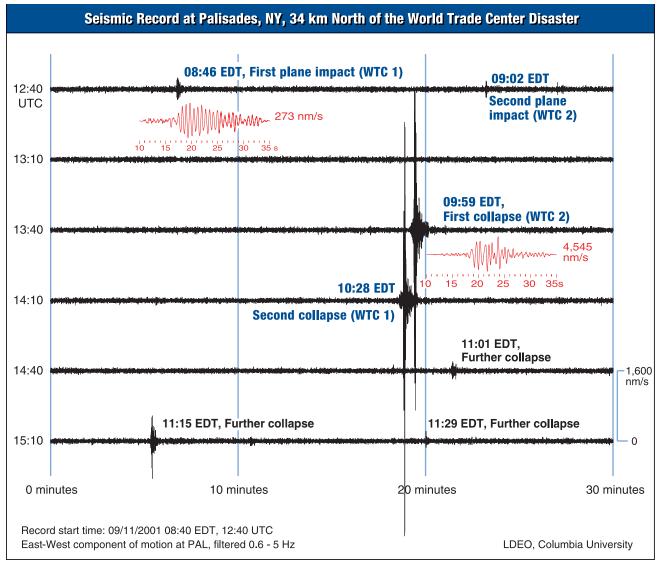
Figure 1-8 Seismic recordings on east-west component at Palisades, NY, for events at WTC on September 11, 2001, distance 34 km. Three hours of continuous data are shown starting at 08:40 EDT (12:40 UTC). The two largest signals were generated by the collapses of towers 1 and 2. Expanded views of first impact and first collapse are shown in red. The amplitude of the seismic signal is in nanometers per second (nm/s), and the peak amplitude of the ground motion at this station reached to 4,545 nm/s for the first collapse. Note the relatively periodic motions for impacts 1 and 2.

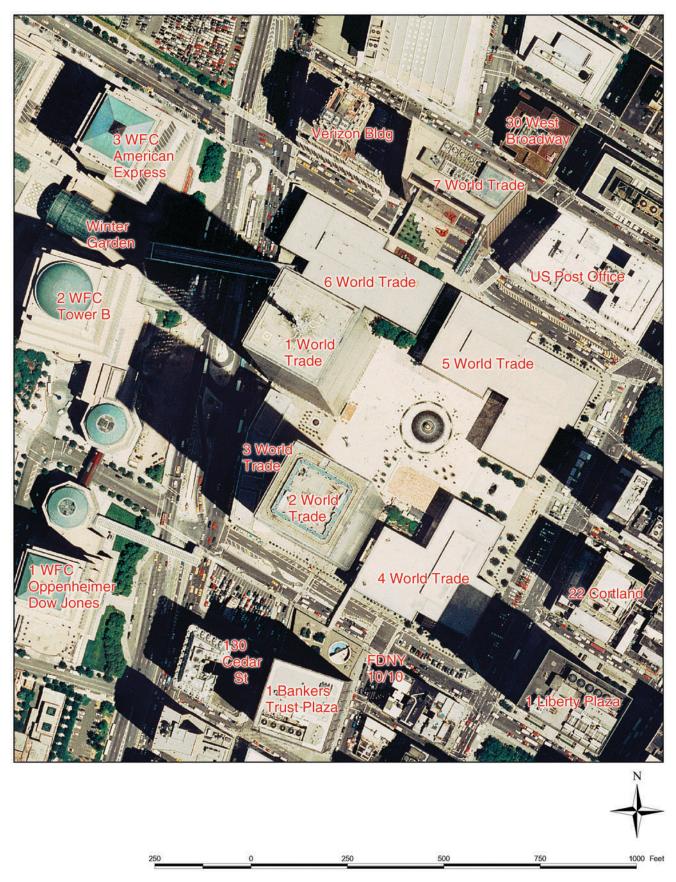
Figure 1-9A Satellite photograph of the WTC site taken before the attacks.
